## Site Inspection Report

PROJECT REF: <b>WWW</b>				DATE: Monday, July 28, 2014		
DESCRIPTION OF WORK: Alterations						
ADDRESS: 39 The Old Common, Chalford, Stroud, Gloucestershire, GL6 8HH,						
SITE CONTACT: Mrs Williams Tel:				WEATHER/TEMP: Mild		
PRESTART	FOUNDATIONS	DPC/OVERSITE	DRAINS	SUPERSTRUCTURE	FIRST FIX/INSULATION	
<input type="checkbox"/>	<input type="checkbox"/>	<input type="checkbox"/>	<input type="checkbox"/>	<input type="checkbox"/>	<input type="checkbox"/>	
LIFE SAFETY INSTALLATIONS		COMMISSIONING	COMPLETION	OCCUPATION	OTHER	PLEASE TICK BOX
<input type="checkbox"/>		<input type="checkbox"/>	<input type="checkbox"/>	<input type="checkbox"/>	<input checked="" type="checkbox"/>	(right click, properties and select checked)
<b>COMMENTS</b>						
COMMENTS Progress inspection undertaken, following noted.

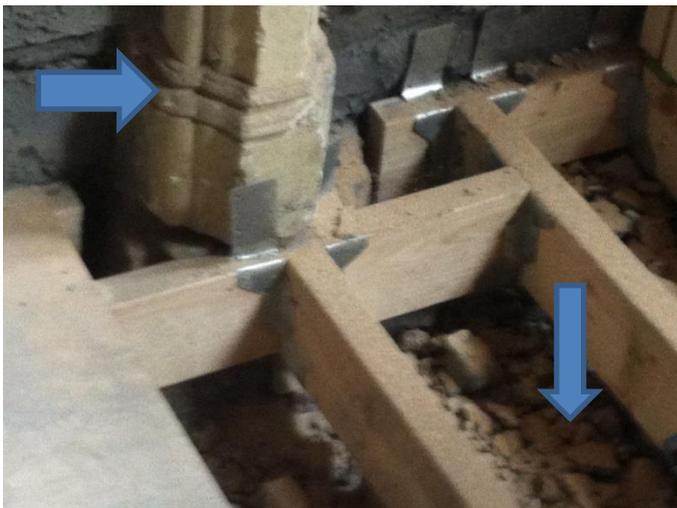
Rubble to be removed from under suspended floor in main building  
Column detail which will be a cold bridging point when wall is insulated.

1. Any rubble which has been back filled under the suspended timber floors in both buildings is to be removed and a polythene dam is to be laid on the existing ground covering (soil) and lap with the dpc under the dwarf support walls to the suspended timber floors.
2. In the school building the suspended timber floor joists are to be cut back 50mm from the face of the existing walls and strip of dpc placed between the joists and the wall.
3. A guarantee has not been requested for the existing timbers being reused although all are going to be treated.

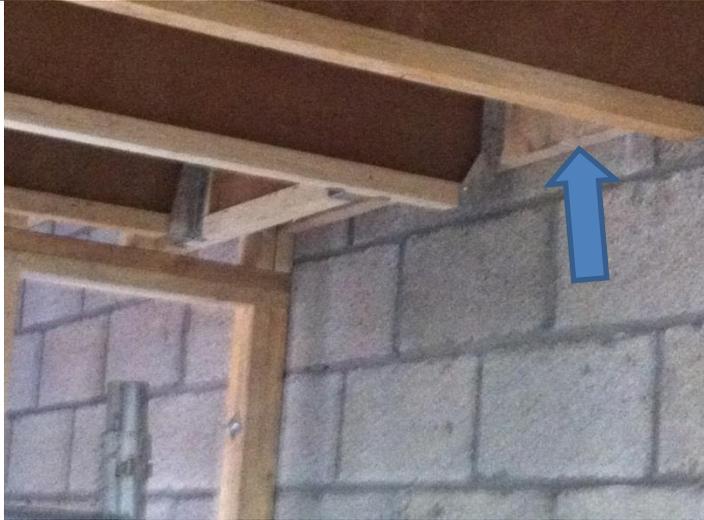
Engineered floor joists adjacent to party wall

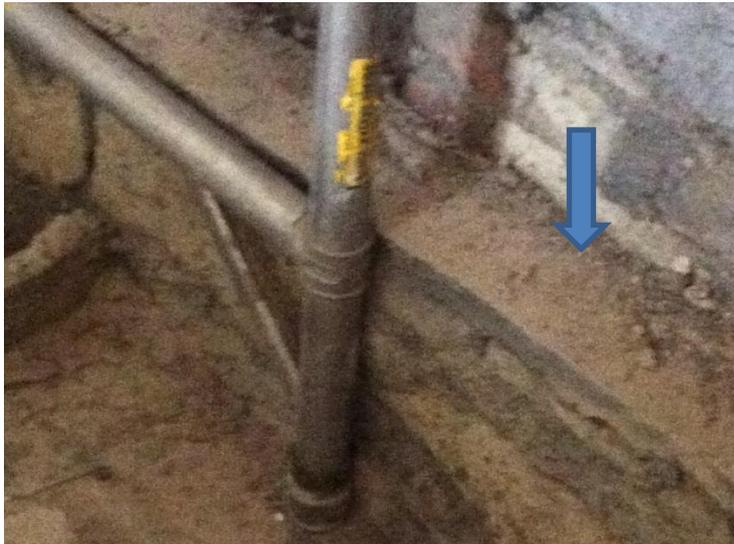
1. There is an existing slate dpc to both buildings. An injected dpc is therefore not proposed.
2. In the school building some of the new floor joists can be seen and centres are 600mm. Contractor said that engineer specified 50 x 150mm joists but 200mm have been used. Generally look to be ok especially as they are all being supported off dwarf walls which will reduce the spans. Has a floor joist layout plan for the suspended timber floors been approved?
3. In both buildings work has commenced on the party walls, in the main building they are generally around first floor height. Noted as dense concrete blocks with fibreglass insulation. Contractor confirmed that sound testing is proposed to all units.
4. In the main building the unit nearest the entrance has engineered floor joists in place for the first floor. **Have details been requested?**

Slate dpc in main church

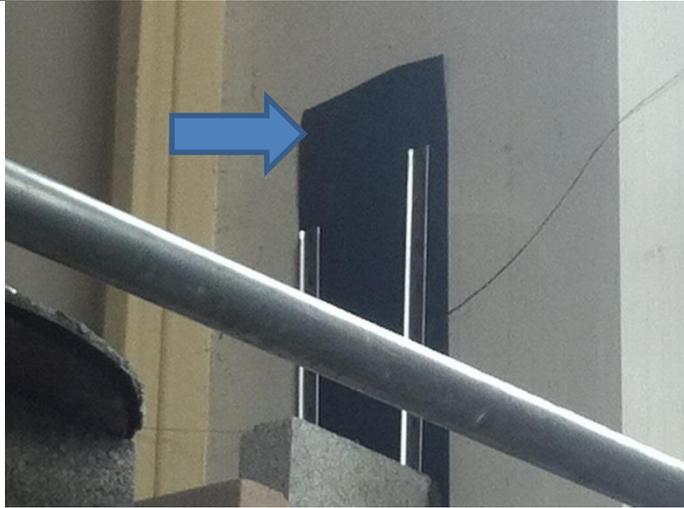
5. The party walls have been fixed to the internal walls using furfix or similar profile with a dpc behind it. It may pay the client to take advice from their proposed sound testing company on this detail.

DPC where new part walls abut existing external walls

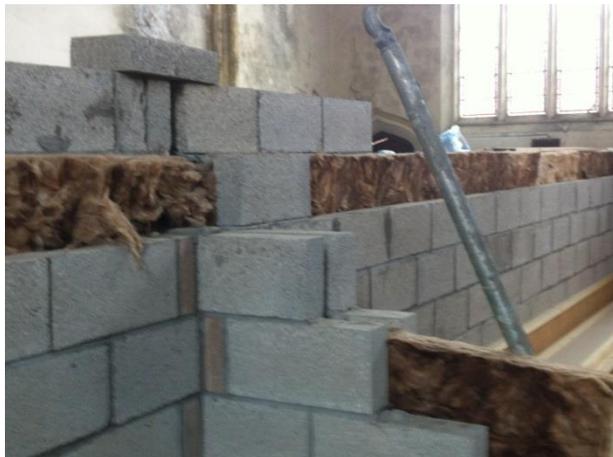
Party Wall Construction in main building

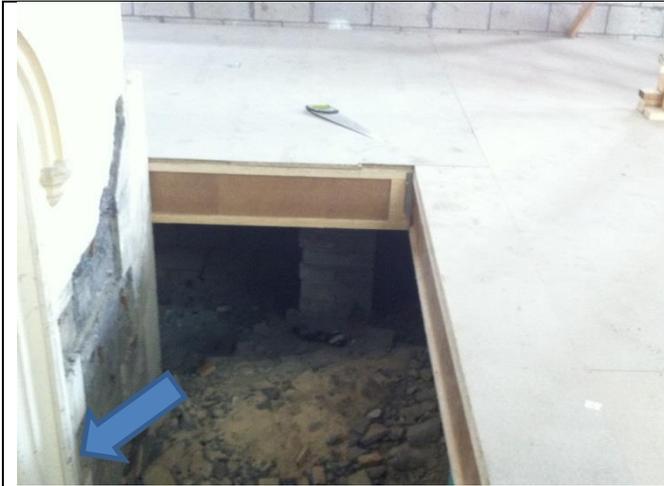
Steps will be formed down here to doorway on left indicated by arrow

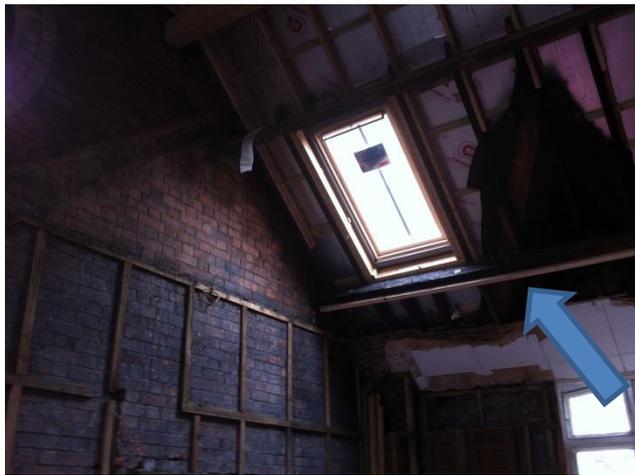
10. Method of insulating the roof in the main church building not yet decided.
11. In the smaller building the rear section of roof has been completed, the lower section being existing and the upper section new. This was partly inspected last time. Noted that the lower existing purlins have been strengthened by bolting a new timber to it, the new timber however is not built into the walls and stops some 50mm short. However the

addition of new purlins higher up will reduce the loading a on the lower purlins so could be argued that it is an improvement on existing. **The engineer has apparently agreed this detail.**

Strengthened purlin see point 11

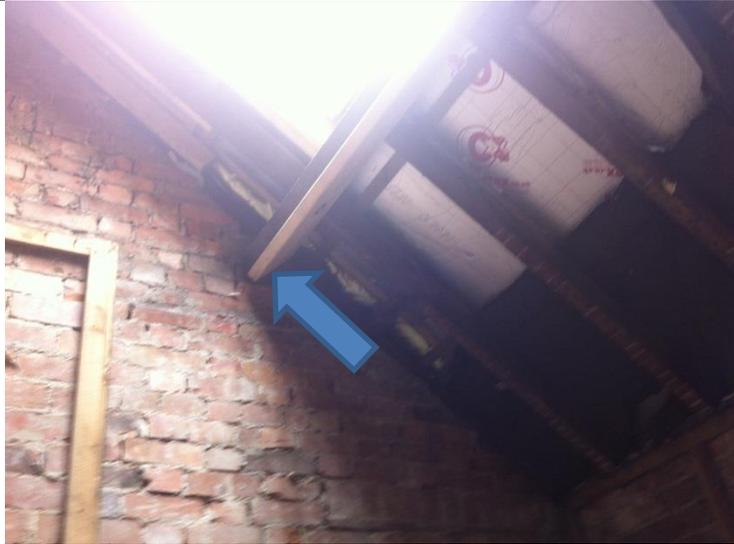
Close up of strengthened purlin (new timber stops 50mm short of wall)

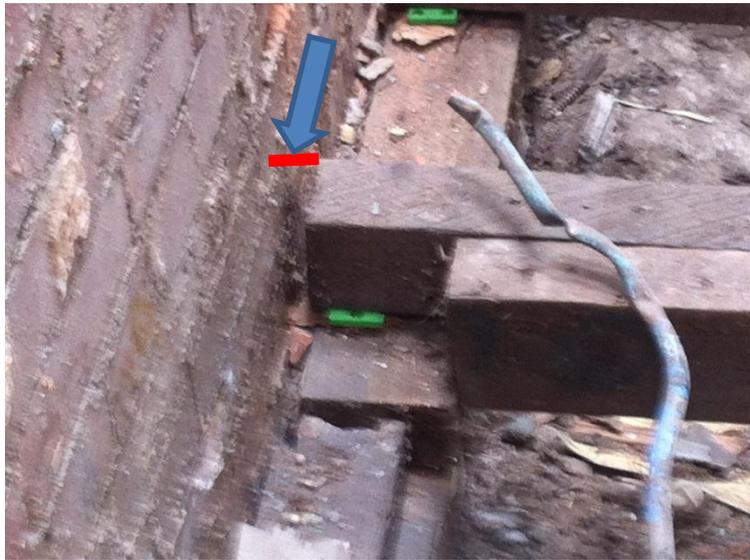
Floor joists to be cut back to 50mm from wall and vertical strip of dpc taped to wall (at request of warranty supplier)
